**Medium Weight Shock and Vibration
Test Report
on
Vertical Pump with 40 HP Motor
for
Sims Pump Valve Co., Inc.
Hoboken, NJ**

NU LABORATORIES, INC.

28 July 2009

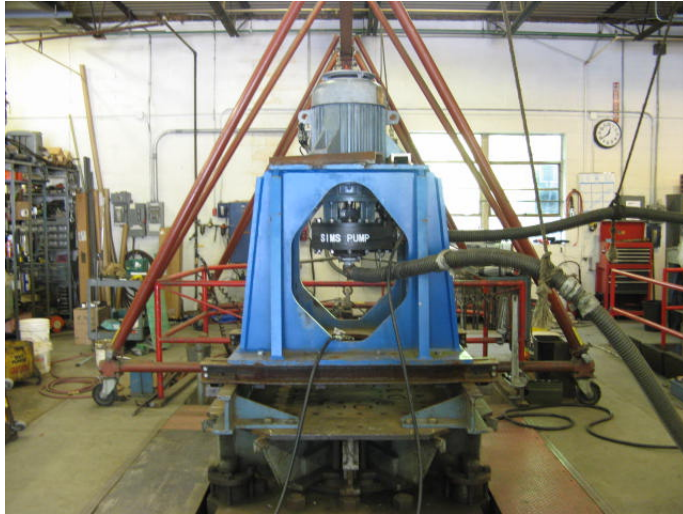
Vertical Axis

12.4.1 Conditions: Vertical Axis, 1.75’ hammer height, Group #I, 3” anvil table travel, Figure 13 of the referenced specifications.

12.4.2 Observations: A post-blow visual inspection revealed no obvious physical damage. No leakage or loss in pressure was reported.

12.4.3 Action: The mounting bolts were retorqued and testing was continued.

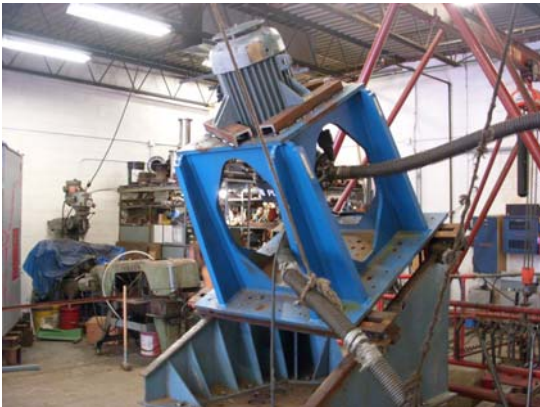
30° Side Down

12.7.1 Conditions: 30° Side Down, 2.25’ hammer height, Group #I, 3” anvil table travel, Figure 16 of the referenced specifications.

12.7.2 Observations: A post-blow visual inspection revealed no obvious physical damage. No leakage or loss in pressure was reported.

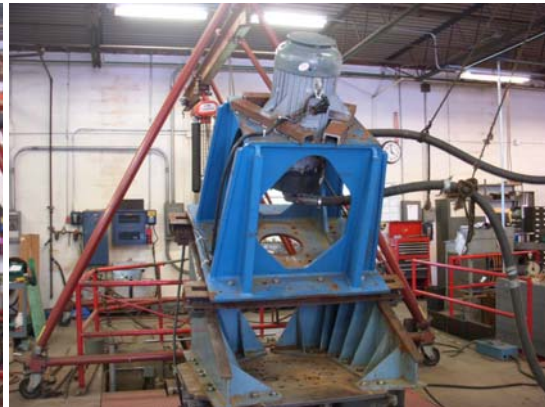
30° Discharge Up

- 12.10.1 Conditions: 30° Discharge Up, 2.25' hammer height, Group #I, 3" anvil table travel, Figure 16 of the referenced specifications.
- 12.10.2 Observations: A post-blow visual inspection revealed no obvious physical damage. No leakage or loss in pressure was reported.
- 12.10.3 Action: Testing was continued.

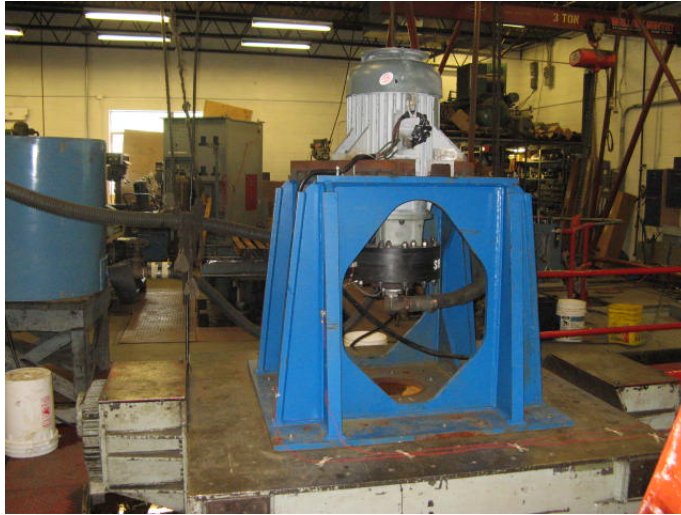
Side to Side and Vertical Axes

The Pump was vibrated from 4 Hz to 50 Hz with input amplitudes as shown in Table 2. The change in frequency was made in discrete intervals of 1 Hz and the vibration was maintained at each frequency for a period of five (5) minutes. No obvious physical damage, leakage or loss in pressure was noted.

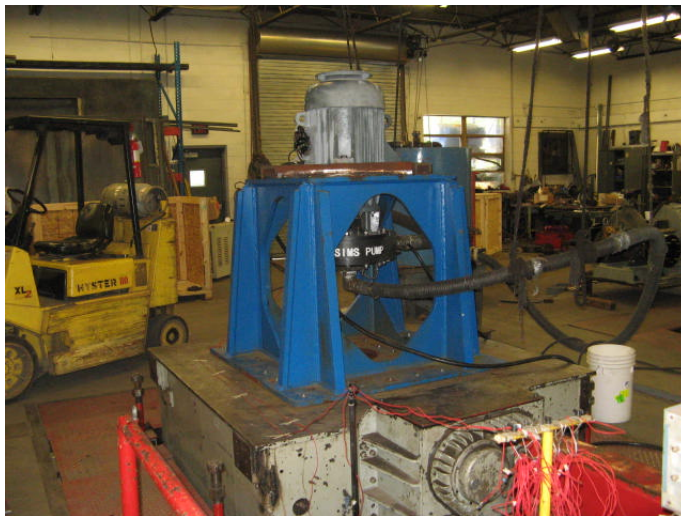
End to End Axis

The Pump was vibrated from 4 Hz to 50 Hz with input amplitudes as shown in Table 2. The change in frequency was made in discrete intervals of 1 Hz and the vibration was maintained at each frequency for a period of five (5) minutes. No obvious physical damage, leakage or loss in pressure was noted.
