05-14-2009

Dave Allen. City of McMinnville, OR Waste Water Treatment Plant. allend@ci.McMinnville.org.us

Ref.: Testimonial for SIMSITE® impellers in Raw Sewage Service.

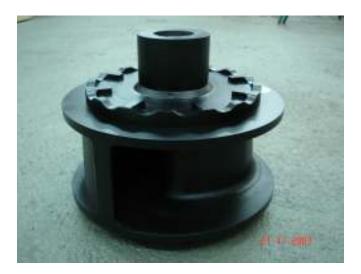
The Original Impeller in the Pump was an ABS cast iron metallic impeller and the pump was constantly plagued with problems primarily caused by the pump operating in a very wide range of flows from 400 GPM to 2000 GPM. Because of this wide range of flows, the pump was constantly working under cavitation and metallic impellers were constantly being destroying and had to be replaced very often.

Cavitation was destroying these cast iron impellers so the customer approached SIMS Pump Company of Hoboken, New Jersey for a solution to the problem.

SIMS designed and manufactured a SIMSITE® Structural Composite Impeller for this pump application. SIMS Engineers used state-of-the-art computerized engineering and manufacturing techniques to optimize the impeller design to reduce the effects of the cavitation damage and to maximize efficiency, performance, and longevity. SIMS modified the vane geometry of the impeller and machined the new SIMSITE® Impeller from a solid block of SIMSITE® structural graphite composite, which enabled SIMS to optimize the impeller design. The new re-engineered structural composite impeller was successfully installed in the pump and the pump was started in 2007. In 2009, the pump was removed from duty and the SIMSITE® Impeller was inspected after (2) two years of continuous operation. The inspection proved that SIMSITE® impeller is impervious to severe operating conditions. The SIMSITE® Impeller showed no signs of cavitation damage. The same SIMSITE® impeller was reinstalled back in the pump.
