**Vibration and Medium Weight Shock Test Report  
on  
1.25" x 1" x 7 Pump with Motor  
for  
Sims Pump Valve Company  
Hoboken, NJ**

**NU LABORATORIES, INC.**  
**312 Old Allerton Road, Annandale, NJ**  
**(908) 713-9300**  
**[WWW.NULABS.COM](http://WWW.NULABS.COM)**  
**E-Mail: [sales@nulabs.com](mailto:sales@nulabs.com)**

**07 April 2008**

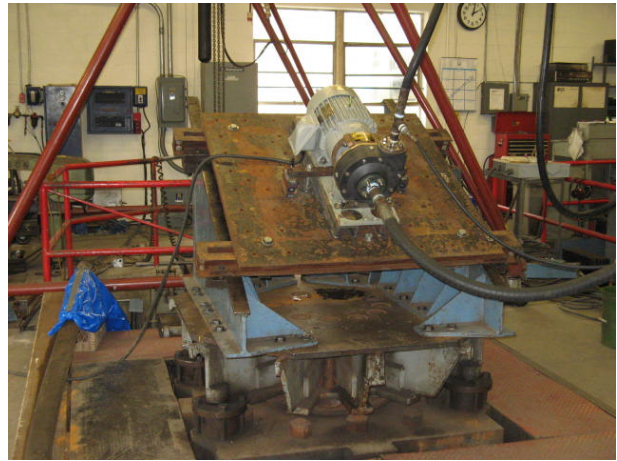
**30° Pump Down**

The entire assembly was removed from fixture Figure 16 of MIL-S-901D, rotated 90° and reattached to MIL-S-901D Figure 16 with the Pump facing down. Refer to Figure 5. The total weight on the anvil table remained at 2760.3 pounds.

**Shock Test Setups  
Figure 5**
