**Medium Weight Shock and Vibration  
Test Report  
on  
3 x 2 x 8 Pump with 40 HP Motor  
for  
Sims Pump Valve Co., Inc.  
Hoboken, NJ**

**NU LABORATORIES, INC.**

**06 December 2006**

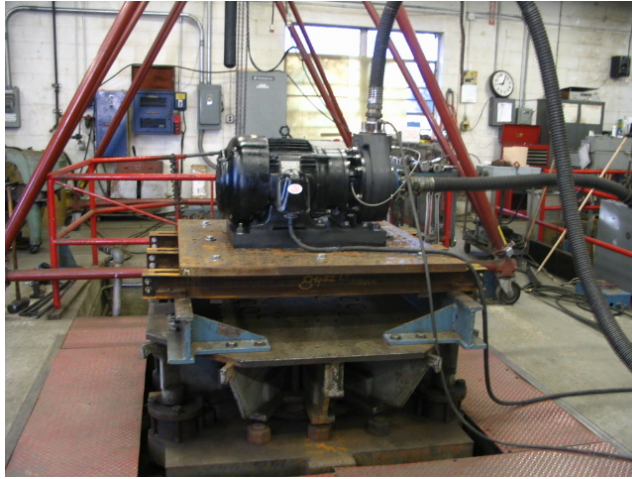
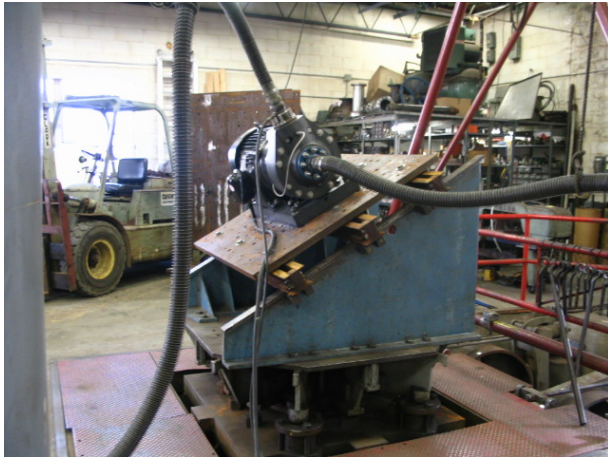
**Shock Test Setups  
Figure 1**

The Pump was attached to a 48" x 48" x 1½" steel plate using four (4) 7/8"-8 Grade 5 bolts torqued to 150 lbs-ft. The entire assembly was secured to fixture Figure 13 of MIL-S-901D on the medium weight shock machine oriented in the first major axis of test. A 54 pound dummy mass was attached to the suction side of the Pump and a 25.5 pound dummy mass was attached to the discharge side of the Pump. The total weight on the anvil table was 2486.5 pounds. Refer to Table 1 for the medium weight shock test weights and Figure 1 for photographs of the test setup.

The entire assembly was then removed from fixture Figure 13 and attached to fixture Figure 16 of MIL-S-901D oriented with the side of the Pump facing down. The total weight on the anvil table was 3576.5 pounds. Refer to Table 1 for a breakdown of the test weights and Figure 1 for the photograph of the test setup.

The entire assembly was removed from fixture Figure 16, rotated and reattached with the Pump down. The total weight on the anvil table remained 3576.5 pounds. Refer to Figure 1 for the photograph of the test setup.

**Vertical Axis**

**30° Side Down**

**30° Pump Down**

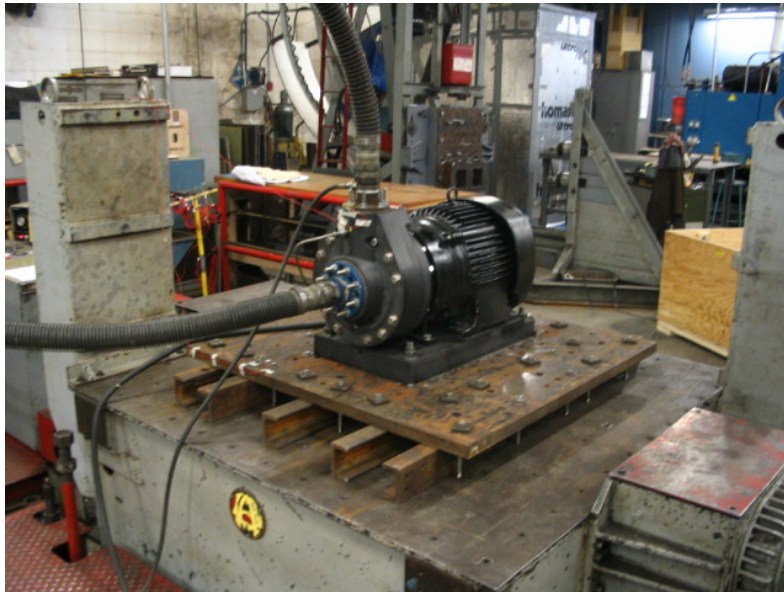
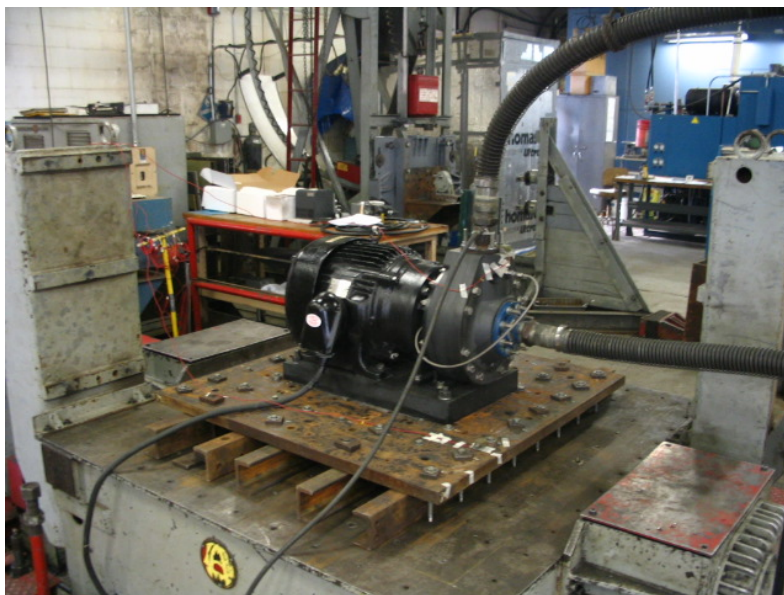
**Vibration Test Setups  
Figure 4**

The Pump was removed from the medium weight shock machine and attached to the vibration machine oriented in the first major axis of test. Refer to Figure 4 for photographs of the test setups.

One (1) accelerometer was attached to the plate and one (1) accelerometer was attached to the top of the Pump, oriented in the direction of vibration, to aid in the detection of response prominences.

The Pump was flooded with water, energized with 440 VAC, three (3) phase, 60 Hz power and operating with the discharge pressure adjusted to 130 psig throughout the vibration test.

**End to End and Vertical Axes**

**Side to Side Axis**
