**Medium Weight Shock and Vibration Test Report
on
8x8x13C20 Horizontal Pump w/ 20 HP Motor
for
Sims Pump Valve Co., Inc.
Hoboken, NJ**

NU LABORATORIES, INC.
312 Old Allerton Road, Annandale, NJ
(908) 713-9300
WWW.NULABS.COM
E-Mail: sales@nulabs.com

21 October 2009

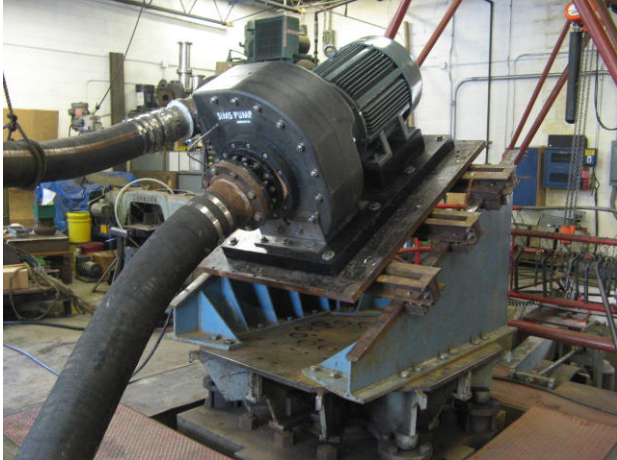
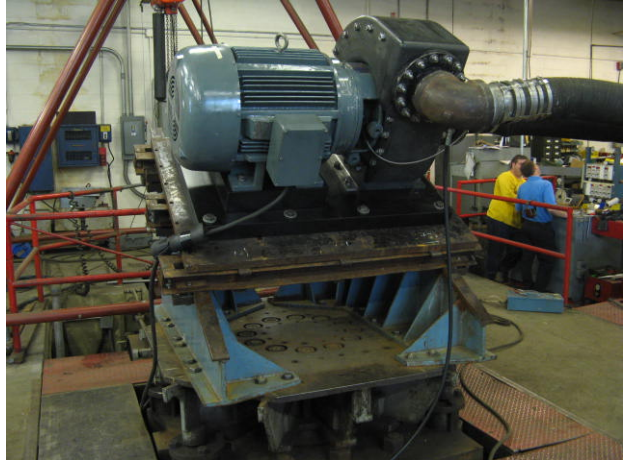
**Shock Test Setups
Figure 1**

The Pump was attached to a 40" x 55" x 1.5" test plate and the plate was secured to fixture Figure 16 of MIL-S-901D. Fixture Figure 16 of MIL-S-901D was secured to the medium weight shock machine oriented in the first major axis of test. The total weight on the anvil table was 4791.5 lbs. Refer to Table 1 for medium weight shock weights and Figure 1 for photographs of the test setup.

30° Side Down Axis

30° End Down Axis

Vertical Axis

The entire assembly was removed from fixture Figure 16 of MIL-S-901D, rotated and reattached to MIL-S-901D Figure 16 with the side of the Pump facing down. Refer to Figure 1. The total weight on the anvil table remained at 4791.5 pounds.

The entire assembly was removed from fixture Figure 16 of MIL-S-901D, and attached to fixture Figure 13 of MIL-S-901D of the referenced specifications. The total weight on the anvil table was 3701.5 pounds. Refer to Figure 1 for a photograph of the test setup and Table 1 for a breakdown of the test weights.

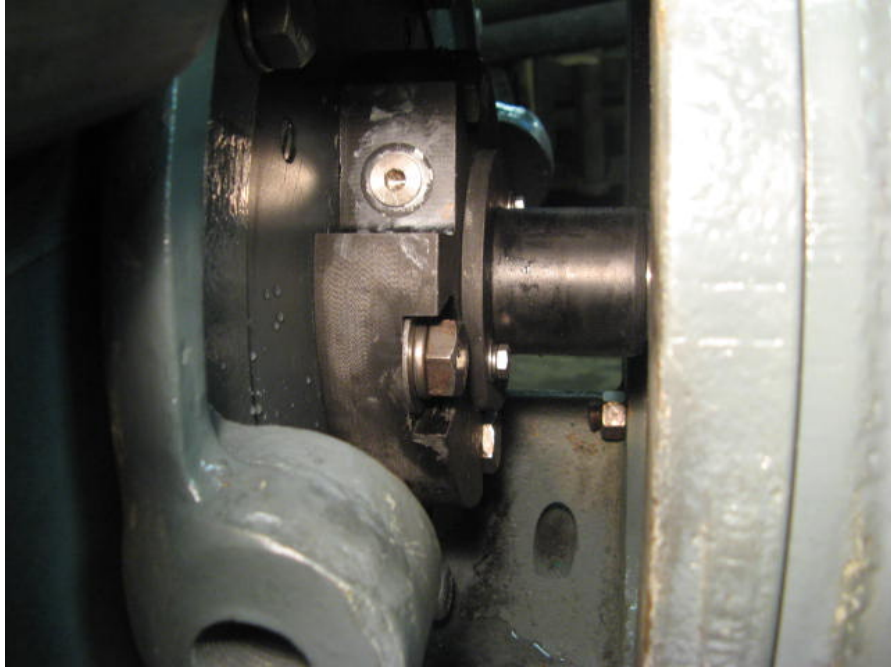
**Post-Blow #6 Pump to Motor Packing Seal Ring
Figure 2**

- 13.8.1 Conditions: 30° Side Down Axis, 3.75' hammer height, Group #III, 1.5" anvil table travel, fixture Figure 16 of the referenced specifications.
- 13.8.2 Observations: A post-blow visual inspection revealed no obvious physical damage. Leakage around the packing seal was noted. The Sims Pump representative reported that the packing ring was not installed.
- 13.8.3 Action: The packing seal ring was installed per the representative's direction. Refer to Figure 2. Testing was continued.

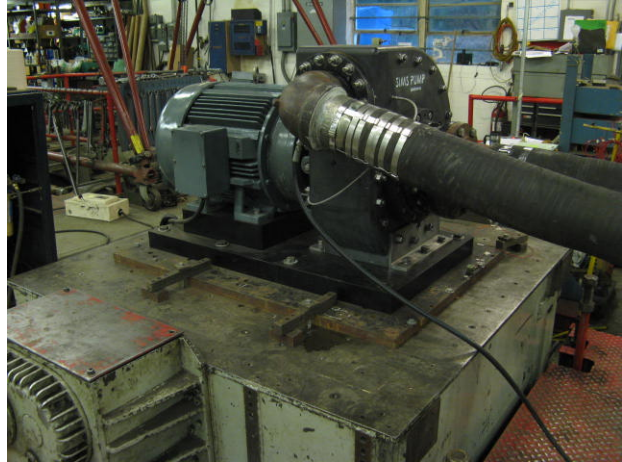
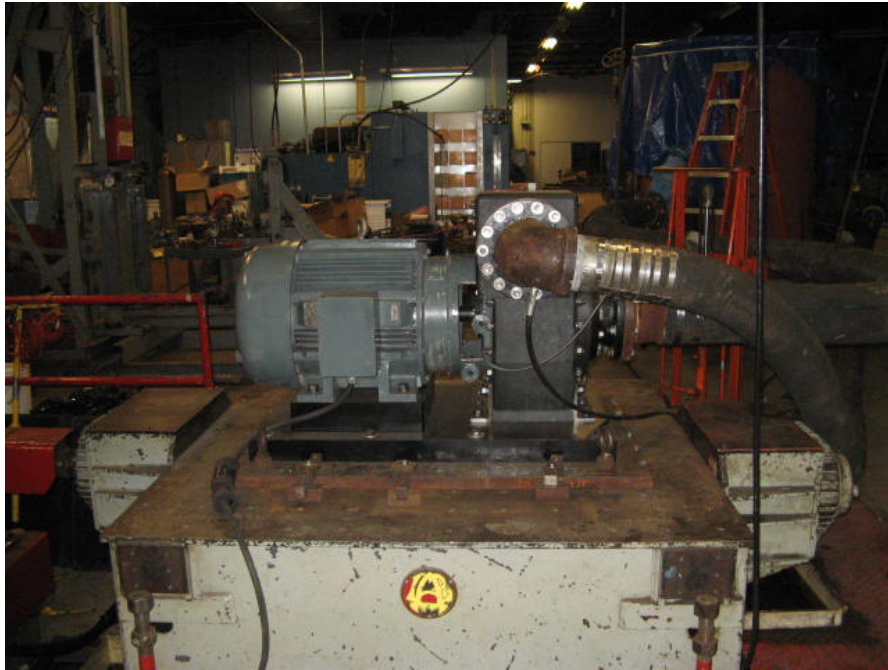
**Vibration Test Setups
Figure 5**

The Pump was attached to the Vibration machine oriented in the first major axis of test. Refer to Figure 5 for photographs of the test setups.

One (1) Accelerometer was attached to the plate and one (1) accelerometer was attached to the top of the Pump, oriented in the direction of vibration, to record the vibration input and to aid in the detection of response prominences.

Vertical Axis

End-to-End Axis

Side-to-Side Axis
