**Medium Weight Shock and Vibration
Test Report
on
1.5" x 1" x 6" Pump with 7.5 HP Motor
for
Sims Pump Valve Co., Inc.
Hoboken, NJ**

NU LABORATORIES, INC.

30 May 2007

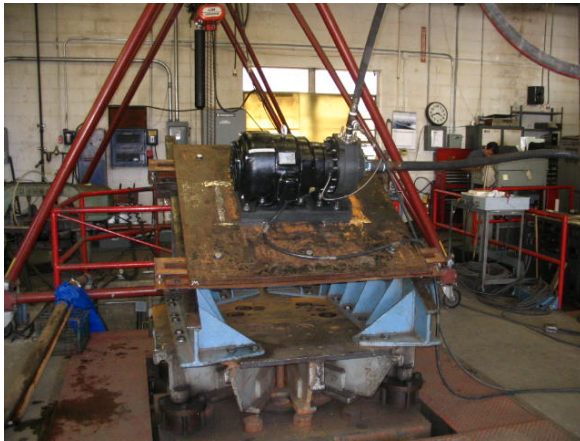
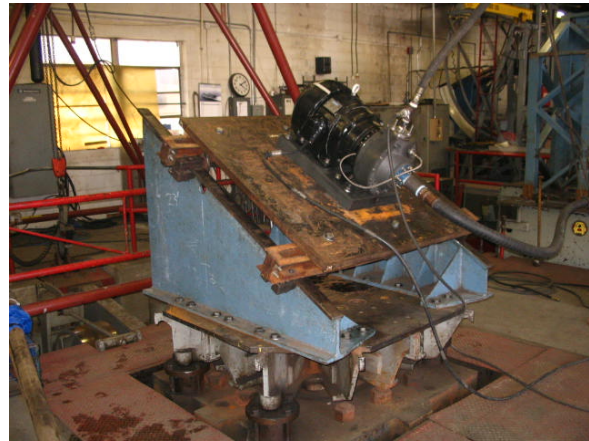
**Shock Test Setups
Figure 1**

The Pump was bolted to a 48" x 48" x 1½" transition plate using four (4) ¾"-10 Grade 5 bolts torqued to 260 ft-lbs. Two (2) half-rails were attached to the transition plate and the entire assembly was secured to fixture Figure 13 of MIL-S-901D on the medium weight shock machine, oriented in the first major axis of test. The total weight on the anvil table was 1954.5 pounds. Refer to Table 1 for the medium weight shock test weights and Figure 1 for the photograph of the test setup.

The entire assembly was removed from fixture Figure 13 of MIL-S-901D and attached to fixture Figure 16 of MIL-S-901D, oriented with the side of the Pump down. The total weight on the anvil table was 3044.5 pounds. Refer to Table 1 for the test weights and Figure 1 for the photograph of the test setup.

The entire assembly was removed from fixture Figure 16, rotated 90°, and reattached to fixture Figure 16 of MIL-S-901D with the front of the Pump facing down. The total weight on the anvil table remained 3044.5 pounds. Refer to Figure 1 for the photograph of the test setup.

Vertical Axis

30° Side Down

30° Front Down

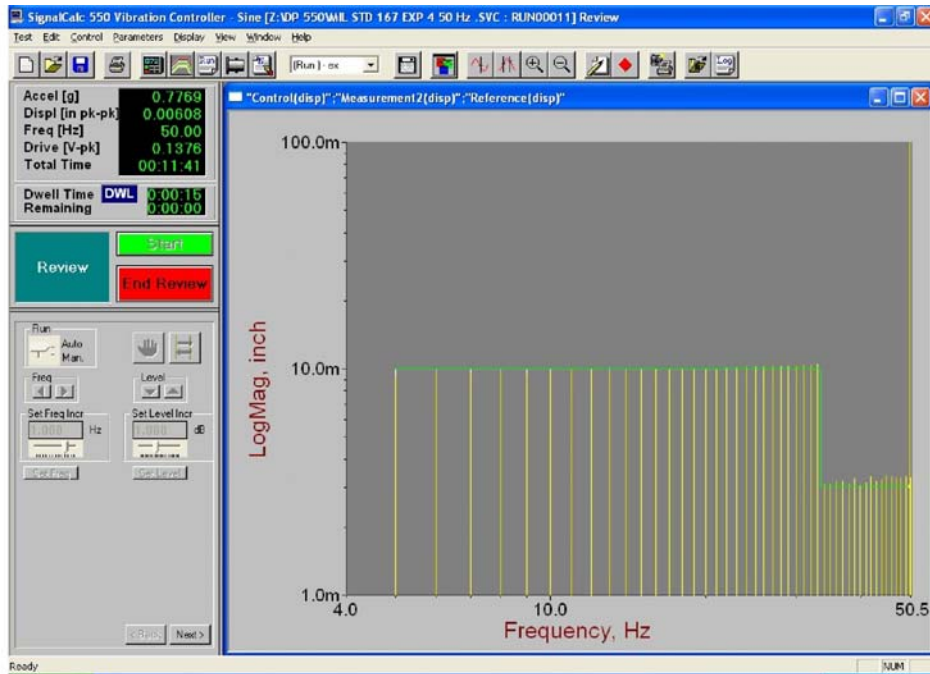
Vibration Plots
 End to End
 Figure 9

The Pump was vibrated from 4 Hz through 33 Hz with a vibration input of 0.020 ± 0.004 inches (double amplitude) to determine response prominences and from 34 Hz through 50 Hz with a vibration input of $0.006 + 0.000/-0.002$ (double amplitude) to determine response prominences. The change in frequency was made in discrete intervals of 1 Hz and the vibration was maintained at each frequency for approximately 15 seconds. No response prominences were noted.

The Pump was vibrated from 4 Hz to 50 Hz with input amplitudes as shown in Table 2. The change in frequency was made in discrete intervals of 1 Hz and the vibration was maintained at each frequency for a period of five (5) minutes. No obvious physical damage, leakage or loss in pressure was noted.

The endurance vibration was performed at the frequency of 50 Hz for a period of two (2) hours. Upon the completion of the two (2) hour dwell, a visual inspection revealed no obvious physical damage, leakage or loss in pressure.

Exploratory

Variable and Endurance

Refer to the Vibration Test Data Sheets, Figures 5 through 7, and the Vibration Plots, Figures 8 through 10, for additional information.
