**Medium Weight Shock and Vibration Test Report**  
**on**  
**3" x 1 1/2" x 6" 15 HP Pump**  
**for**  
**Sims Pump Valve Company**  
**Hoboken, NJ**

**NU LABORATORIES, INC.**  
**312 Old Allerton Road, Annandale, NJ**  
**(908) 713-9300**  
**[WWW.NULABS.COM](http://WWW.NULABS.COM)**  
**E-Mail: [sales@nulabs.com](mailto:sales@nulabs.com)**

**26 October 2005**

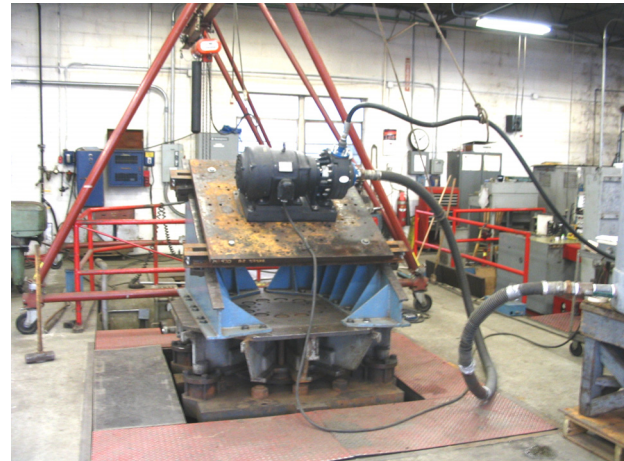
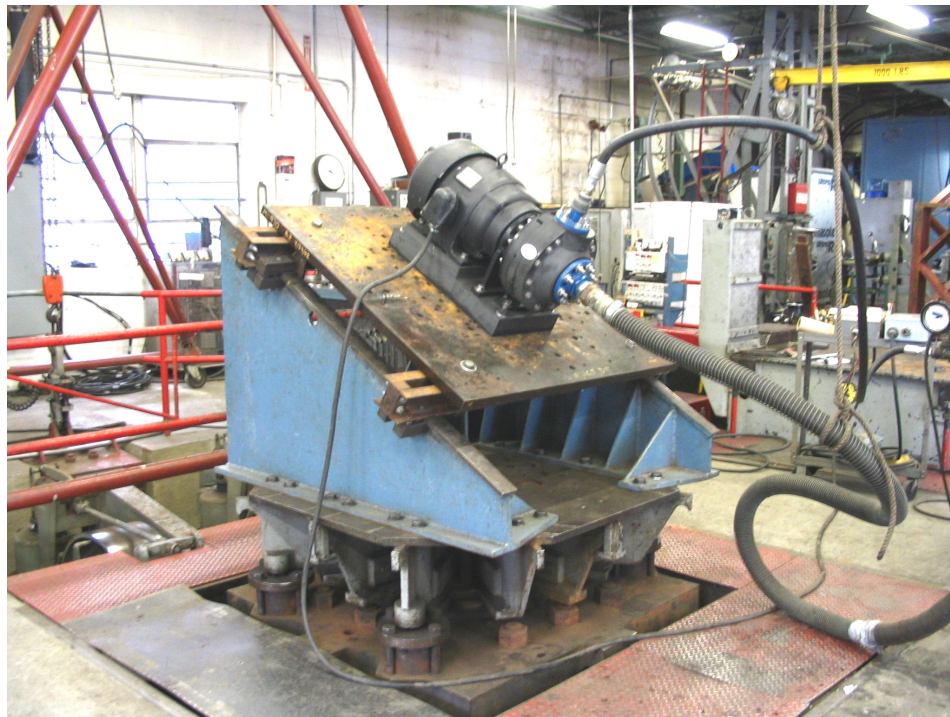
**Shock Test Setup Photographs  
Figure 1**

The Pump was attached to a 48" x 48" x 1 1/2" steel plate using four (4) 7/8"-8 Grade 5 bolts torqued to 400 lbs-ft. The entire assembly was then secured to fixture Figure 13 of MIL-S-901D on the medium weight shock machine orientated in the first major axis of test. A 54 pound dummy mass was attached to the suction side of the Pump using six (6) 1/2"-13 B7 threaded rod, nuts and washers torqued to 45 lbs-ft. A 18.5 pound dummy mass was attached to the discharge side of the Pump using six (6) 1/2"-13 B7 threaded rod, washers, and nuts torqued to 45 lbs-ft. The total weight on the anvil table was found to be 2,091.5 pounds. Refer to Table 1 for the medium weight shock test weights and Figure 1 for photographs of the test setup.

The entire assembly was then removed from fixture Figure 13 of MIL-S-901D, and reattached to fixture Figure 16 of MIL-S-901D of the referenced specifications, orientated with the side of the Pump facing down. The total weight on the anvil table was found to be 3,181.5 pounds. Refer to Figure 1 for a photograph of the test setup and Table 1 for a breakdown of the test weights.

The entire assembly was removed from fixture Figure 16 of MIL-S-901D, rotated 90° and reattached to MIL-S-901D Figure 16 with the suction side of the Pump facing down; see Figure 1. The total weight on the anvil table remained at 3,181.5 pounds.

**Vertical Axis**

**Pump Shaft Perpendicular to Incline Axis**

**Pump Shaft Parallel to Incline**

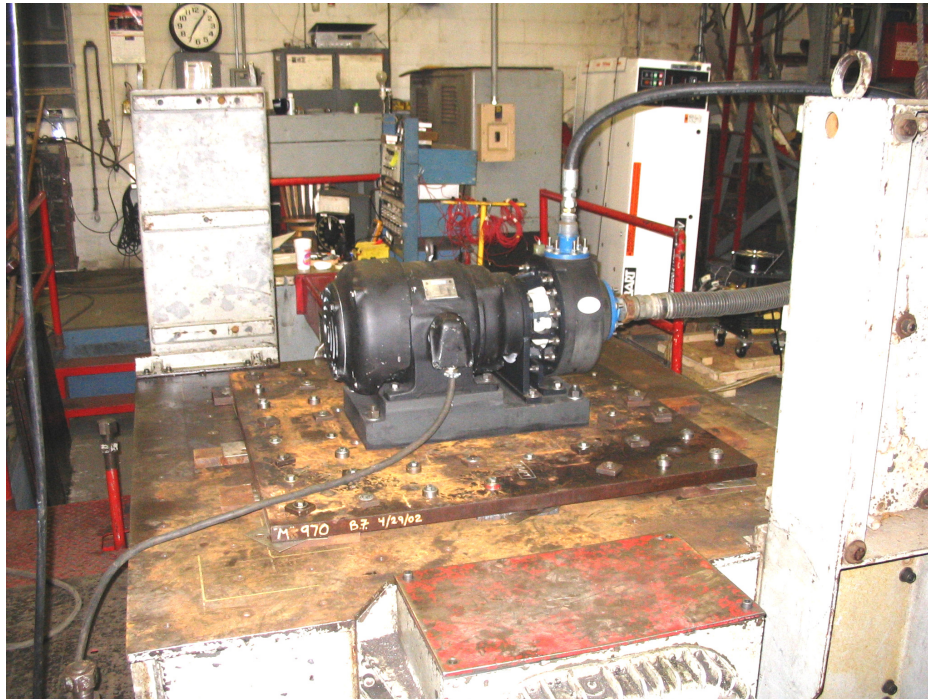
**Vibration Test Setup  
Figure 4**

Upon completion of the shock test the Pump assembly was removed from Figure 16 of MIL-S-901D and attached to the vibration machine. Refer to Figure 4 for the photographs of the test setups.

An accelerometer was attached to the Pump, orientated in the direction of vibration, to aid in the detection of response prominences.

**Vertical and Front to Back Axes**

**Side to Side Axis**
