Medium Weight Shock and Vibration Test Report
on
4" x 4" x 9", 20 HP Pump
for
Sims Pump Valve Company
Hoboken, NJ

NU LABORATORIES, INC.
312 Old Allerton Road, Annandale, NJ
(908) 713-9300
WWW.NULABS.COM
E-Mail: sales@nulabs.com

10 January 2008

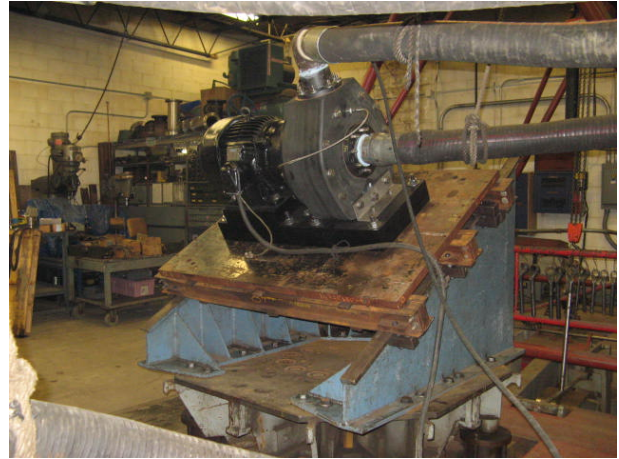
30° Side Down

The entire assembly was removed from fixture Figure 13 of MIL-S-901D, and reattached to fixture Figure 16 of MIL-S-901D of the referenced specifications, oriented with the side of the Pump facing down. The total weight on the anvil table was 3563.5 pounds. Refer to Figure 1 for a photograph of the test setup and Table 1 for a breakdown of the test weights.

**Shock Test Setup Photographs
Figure 1**

- 12.7.1 Conditions: 30° Side Down, 1.75' hammer height, Group #I, 3.0" anvil table travel, Figure 16 of the referenced specifications.
- 12.7.2 Observations: A post-blow visual inspection revealed no obvious physical damage. No leakage or loss in pressure was reported.
- 12.7.3 Action: Testing was continued.

- 12.8.1 Conditions: 30° Side Down, 2.75' hammer height, Group #II, 3.0" anvil table travel, Figure 16 of the referenced specifications.
- 12.8.2 Observations: A post-blow visual inspection revealed no obvious physical damage. No leakage or loss in pressure was reported.
- 12.8.3 Action: Testing was continued.

- 12.9.1 Conditions: 30° Side Down, 2.75' hammer height, Group #III, 1.5" anvil table travel, Figure 16 of the referenced specifications.
- 12.9.2 Observations: A post-blow visual inspection revealed no obvious physical damage. No leakage or loss in pressure was reported.
- 12.9.3 Action: Testing was continued.
