Medium Weight Shock and Vibration Test Report on 6 x 5 150 HP Fire Pump for Sims Pump Valve Company Hoboken, NJ

The purpose of this test was to demonstrate that the 6 x 5 150 HP Fire Pump attached to the composite base, hereinafter referred to as the "Pump," complied with the requirements of MIL-S-901D for a Grade A, Class I, Type A, nine (9) blow medium weight shock test and the requirements of MIL-STD-167-1 when subjected to vibration through the frequency range of 4 Hz through 50 Hz in each of the three (3) major axes.

6 x 5 150 HP Fire Pump Composite Base: M/N NB16969 Serial No.: —1

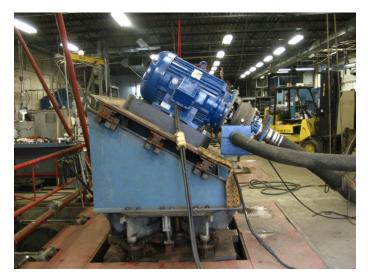
Shock Test Setup Photographs Figure 1

The Pump was attached to a $60'' \ge 60'' \ge 1''$ steel plate using eight (8) 7/8''-8 Grade 5 bolts torqued to 150 lbs-ft. The entire assembly was then secured to fixture Figure 13 of MIL-S-901D on the medium weight shock machine orientated in the first major axis of test. A 157 pound dummy mass was attached to the suction side of the Pump using twelve (12) 5/8''-11 studs torqued to 80 lbs-ft. A 116 pound dummy mass was attached to the discharge side of the Pump using eight (8) 5/8''-11 bolts torqued to 80 lbs-ft. The total weight on the anvil table was 5229 pounds. Refer to Table 1 for the medium weight shock test weights and Figure 1 for photographs of the test setup.

Vertical Axis

30° Side Down

30° Pump Down

The entire assembly was then removed from fixture Figure 13 of MIL-S-901D, and reattached to fixture Figure 16 of MIL-S-901D of the referenced specifications, orientated with the side of the Pump facing down. The total weight on the anvil table was 6319 pounds. Refer to Figure 1 for a photograph of the test setup and Table 1 for a breakdown of the test weights.

The entire assembly was removed from fixture Figure 16 of MIL-S-901D, rotated 90° and reattached to MIL-S-901D Figure 16 with the Pump facing down. Refer to Figure 1. The total weight on the anvil table remained at 6319 pounds.

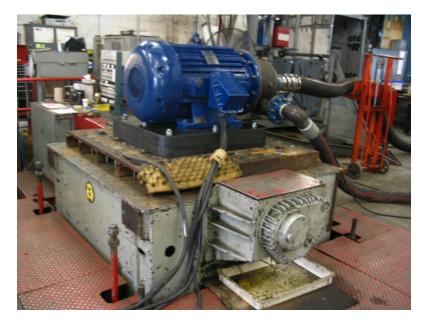
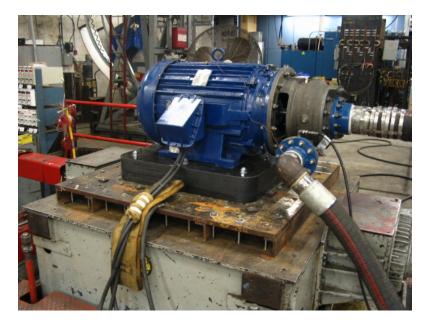
Vibration Test Setup Figure 4

Upon completion of the shock test the Pump assembly was removed from Figure 16 of MIL-S-901D and attached to the vibration machine. Refer to Figure 4 for photographs of the test setups.

One (1) accelerometer was attached to the plate and one (1) accelerometer was attached to the Pump, orientated in the direction of vibration, to aid in the detection of response prominences.

End to End and Vertical Axes

Side to Side Axis
