# Non-Clogging SIMSITE® Structural Composite Impeller Converts Centrifugal pump into Sludge Handling Pump.

## 1 Introduction

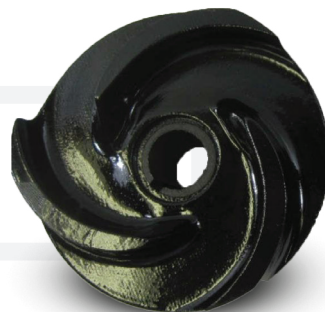
Pic.1 SIMSITE® Structural Composite Non-Clogging Impeller.

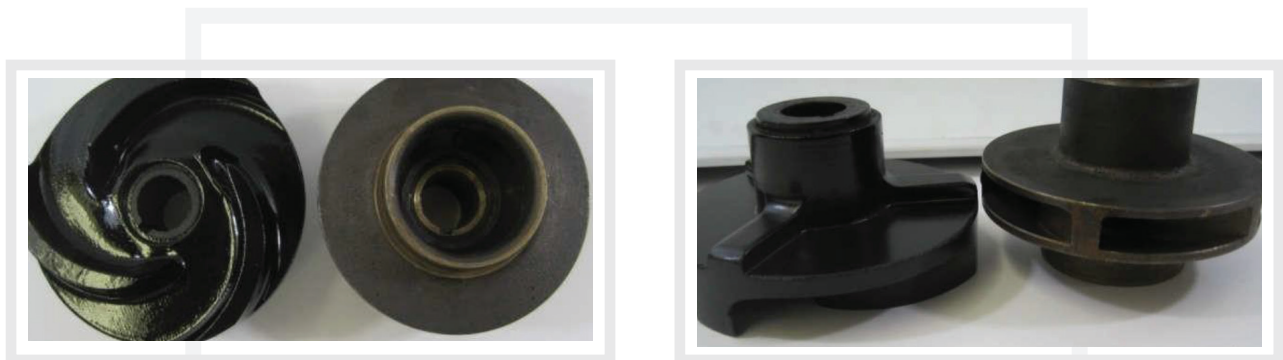
Pic.3 SIMSITE® Non Clogging Impeller next to Conventional Enclosed Impeller.

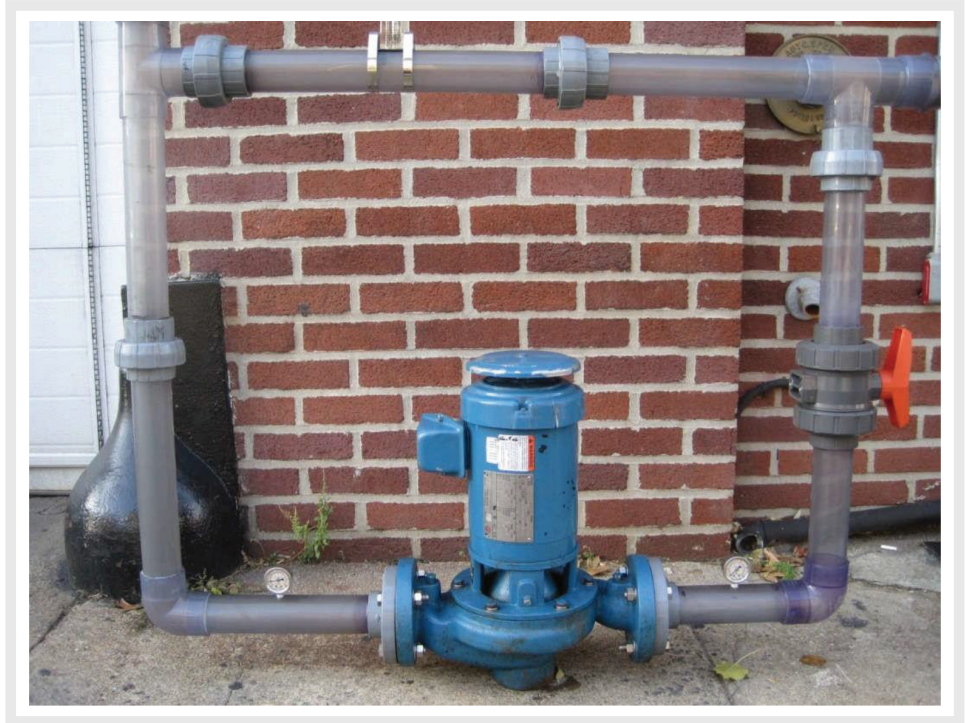
The Test Stand was built out of transparent piping allowing for observation of the flow circulation.

The subject pump was tested first in the Close Loop Test Stand on clear water with the Enclosed Metallic Impeller and then with the SIMSITE® Non-Clogging Impeller. Below is the picture of the Stand.

»»  
Pic.4 Pump on a Transparent Closed Loop Test Stand

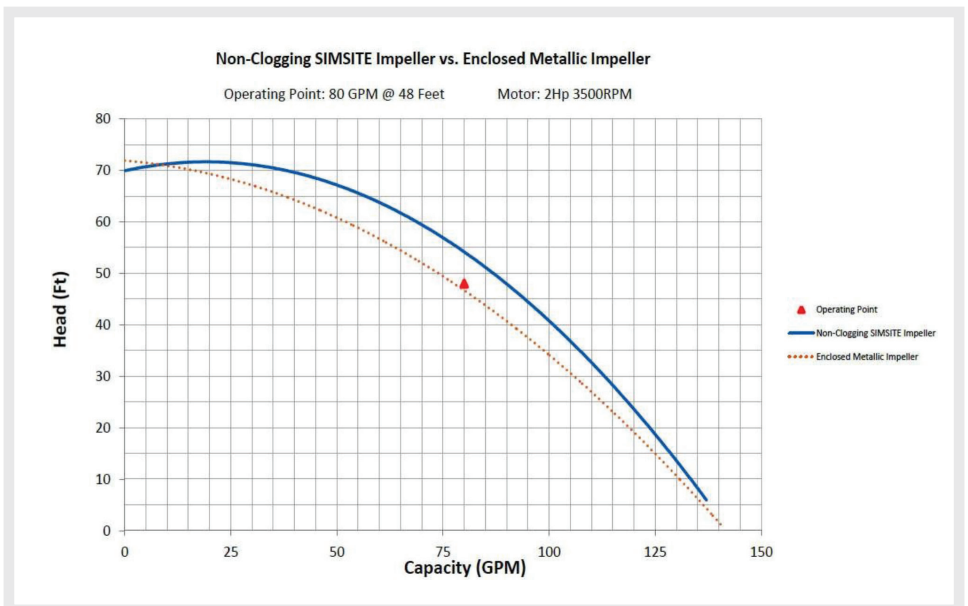
The graph below shows the pump performance with the SIMSITE® Non-Clogging Impeller vs. the Enclosed Metallic Impeller.

It can be seen that the Non-Clogging Impeller matches and even outperform the Enclosed Metallic Impeller. This testing was done with clean water; no fibers had been added into the loop.

»»  
Pic. 5 Comparison of Pump Performance with SIMSITE® Non-Clogging Impeller vs. Conventional Enclosed Impeller.

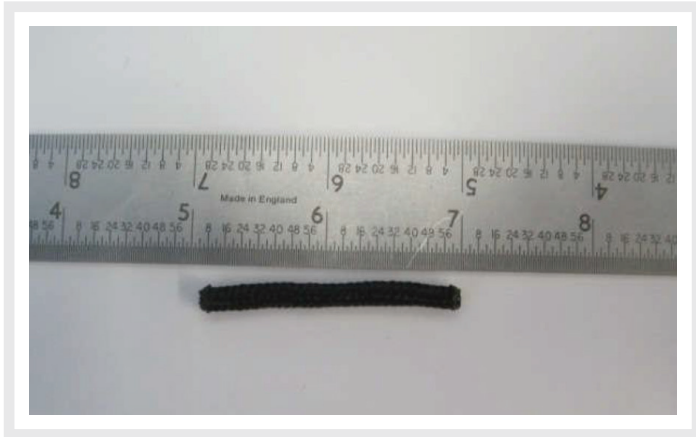
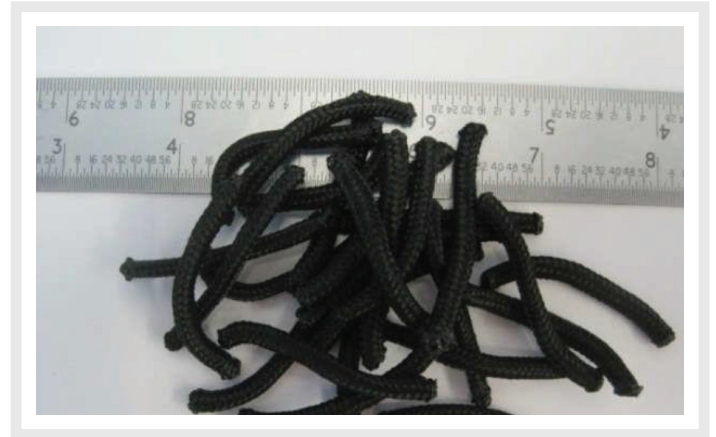
The 2 inches long, 1/8 inch diameter soft flexible nylon rope was cut for the test. The pictures below show an individual fiber and a number of them together ready for the String Handling Test.

Pic.7 Simulation of fibrous Material
